# TEST REPORT LOADBEARING WALL

<b>Name of sponsor:</b>	Wood:UpHigh		
<b>Product name:</b>	Loadbearing deck		
<b>File no.:</b>	PGA12222A	<b>Revision no.:</b>	1
<b>Test date:</b>	2022-12-19	<b>Date:</b>	04-07-2023
<b>Pages:</b>	11	<b>Encl.:</b>	53
<b>Ref:</b>	JBK	/	RKP

EN 1365-2:2014 Fire resistance tests for loadbearing elements - Part 2: Floors

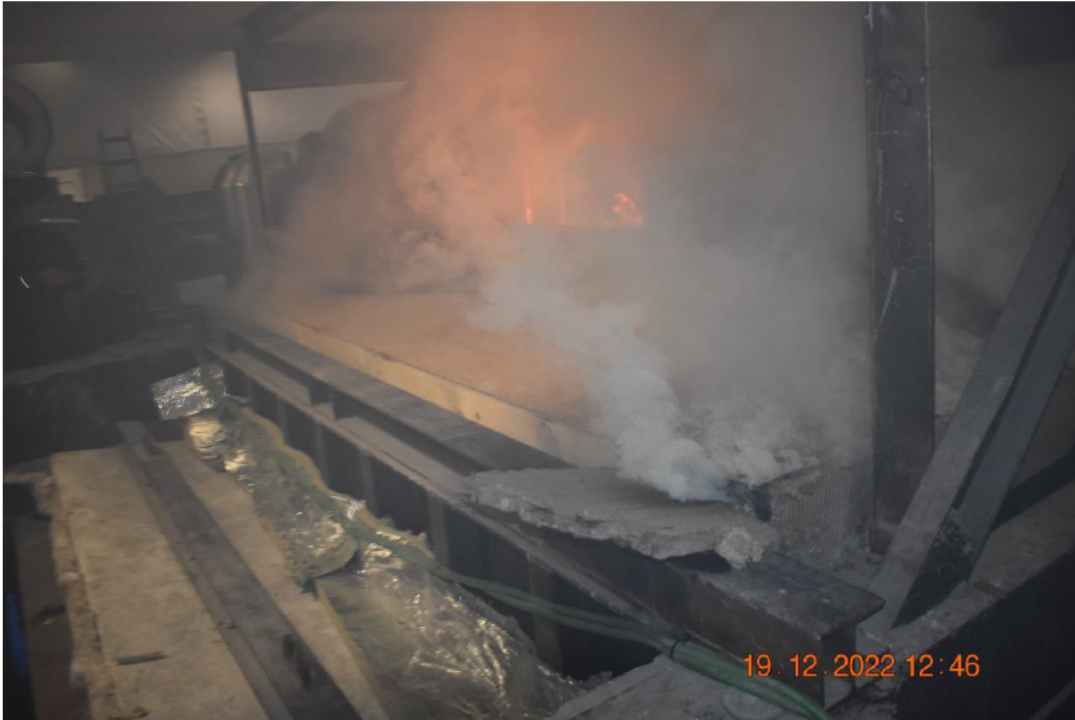
Photo No. 15 Test specimen seen from unexposed side after 49 minutes of testing

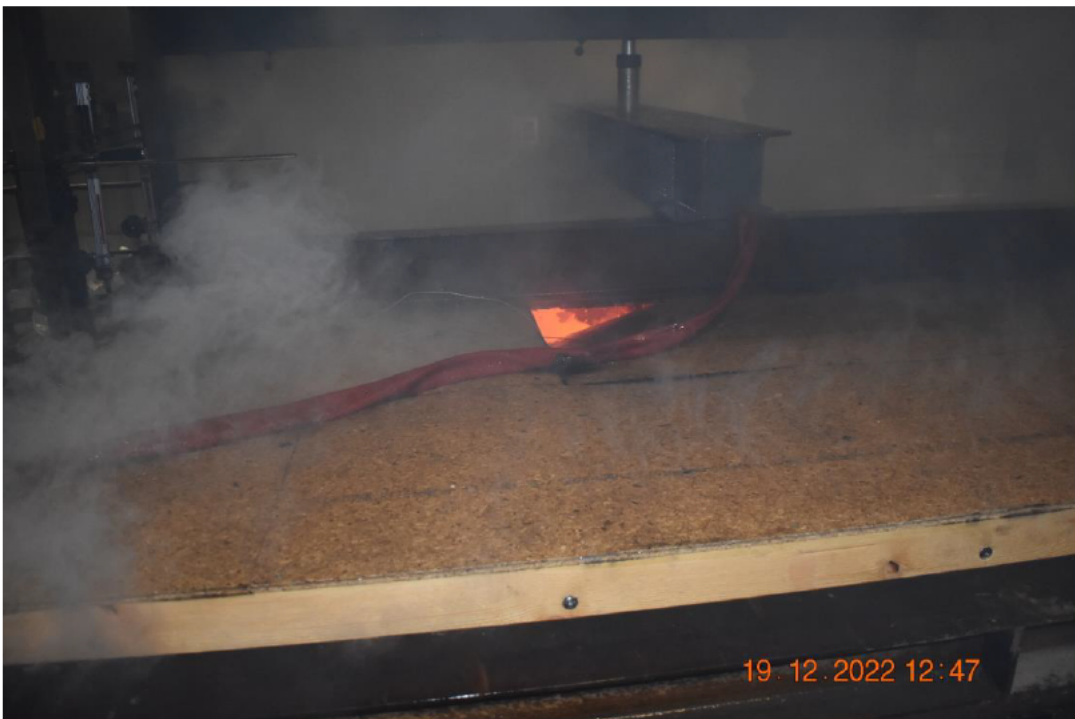
Photo No. 16 Test specimen seen from unexposed side after 50 minutes of testing

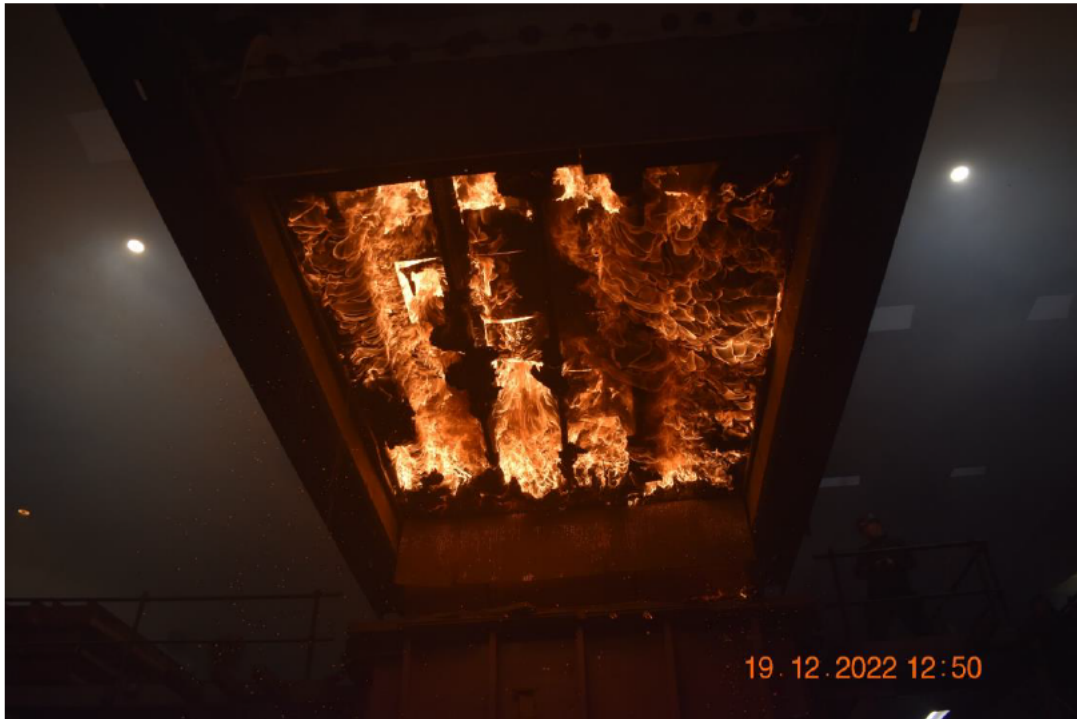
37	All clay boards have fallen down.	E
38	Faint smoke development between joints in top surface	U
41	Popping sounds from burning wood	U
42	Cotton pad test over joint at mid length: no ignition, faint discoloration	U
43	Increase in smoke development from joint in top surface	U
45	Cotton pad test over joint at mid length: no ignition, discoloration	U
46	Discoloration at top surface along the short edge	U
48	25 mm gap gauge could pass through construction by the second beam to the right	U
49	Test stopped

Photo No. 17 Test specimen seen from exposed side after the test

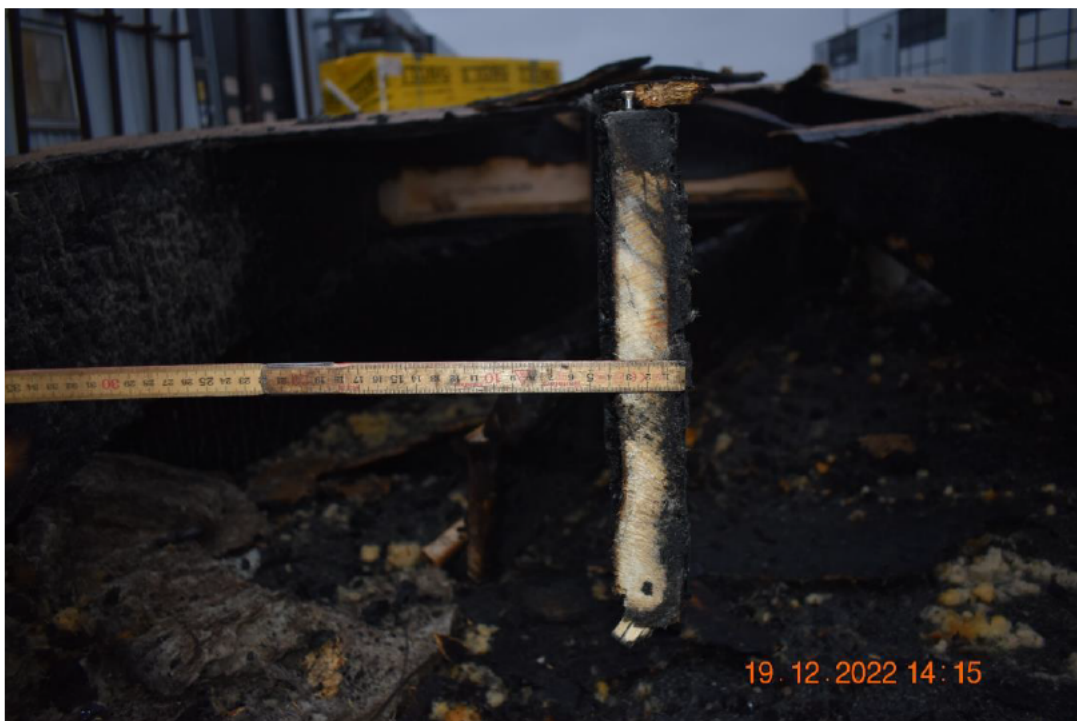
Photo No. 18 Loadbearing beams after the test

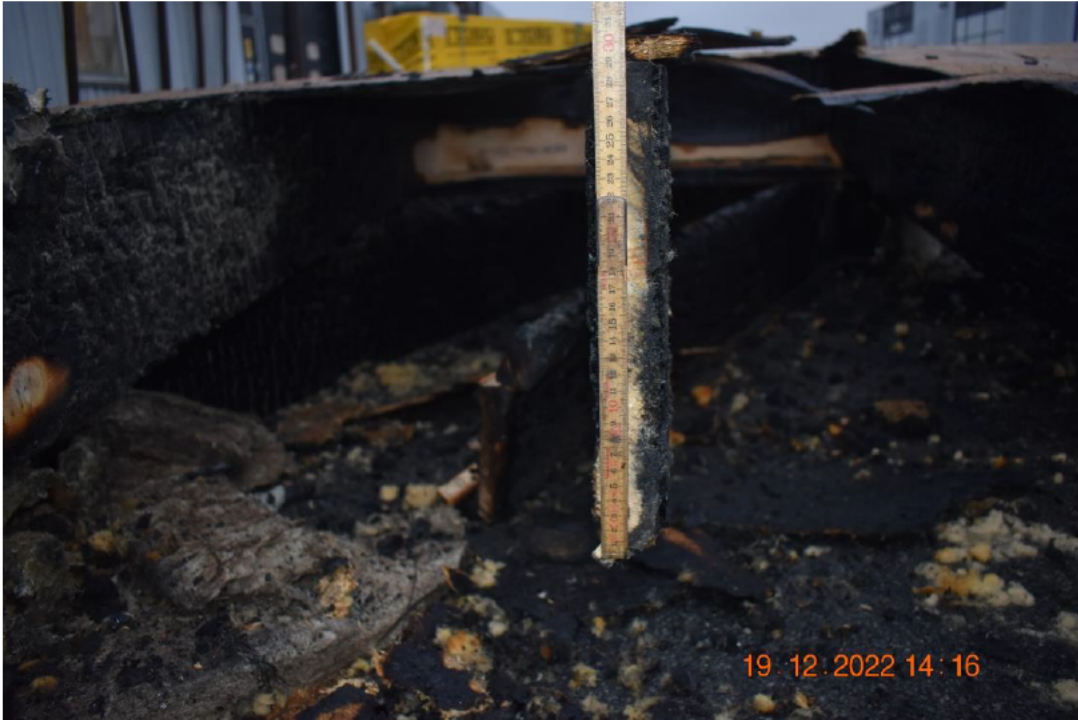
Photo No. 19 Loadbearing beams after the test
